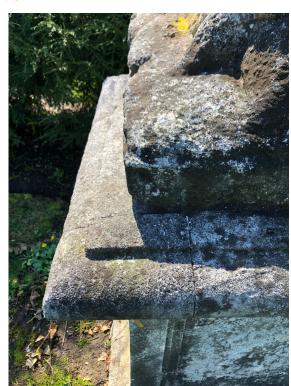
S1 dutchman corner plinth

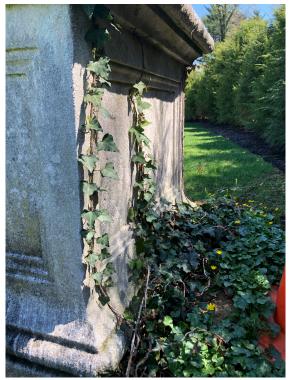
S1 ivy plants on plinth

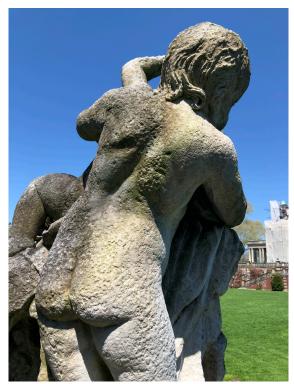
S1 back deterioriated stone; surface loss

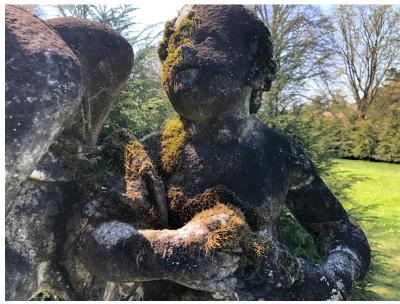
S1 detail biological growth

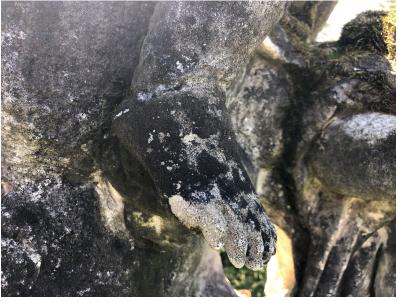
S1 foot weathered limestone

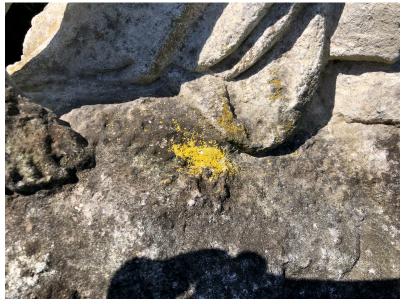
S1 presumed lichen detail

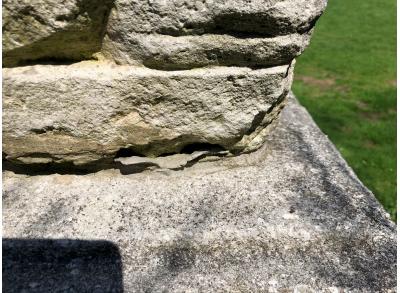
S1 plastic repair mortar join

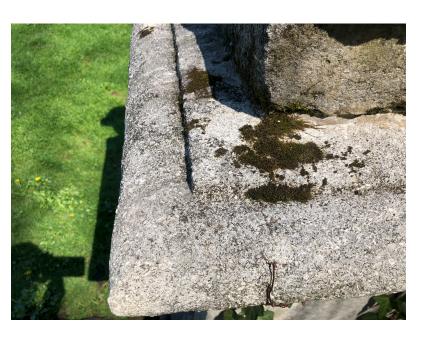
S1 crack, delamination on plinth

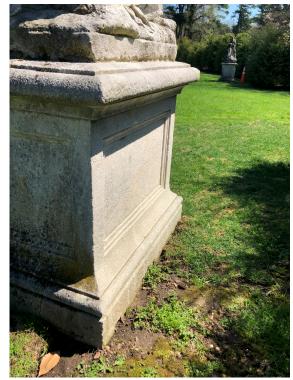
S2 growth, deterioriation

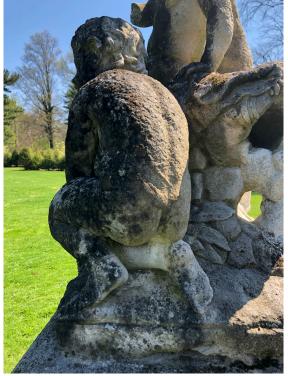
S2 dutchman

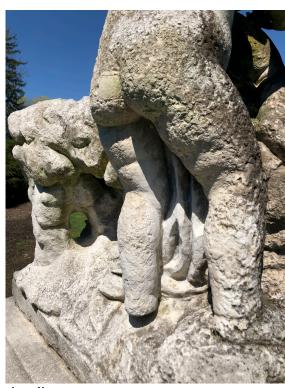
S2 plastic fill prior repair

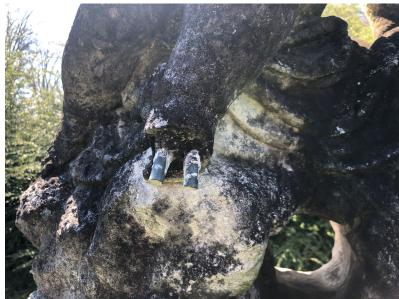
S2 missing foot prior repair

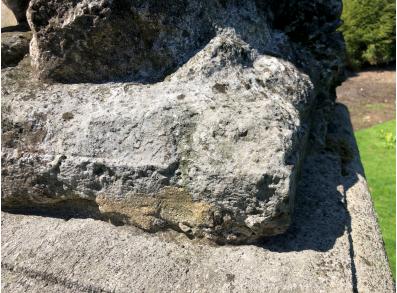
S2 stone surface loss

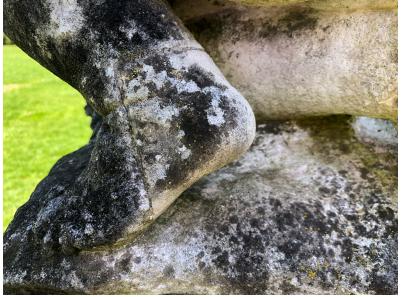
S2 detail dutchman fill

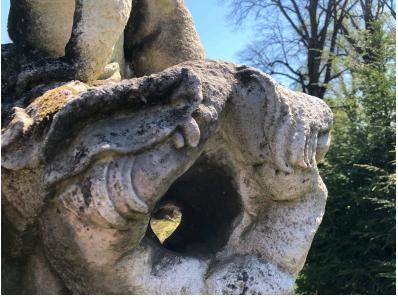
S2 carving better preserved
